CHEMICAL COMPATIBILITY OF CARTRIDGE MATERIALS

TWELVE MONTH PROGRESS REPORT

NASA-NAG8-846

R.C. Wilcox and R.H. Zee

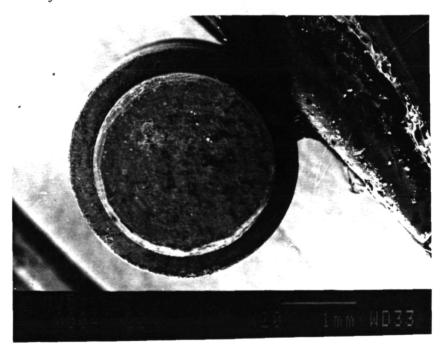
Figure 11 shows the plug end of the cylinder from Figure 7. No cracks in the molybdenum cylinder were evident in either Figure 7 or Figure 11. Tungsten was found on the outer surface of the cylinder after treatment (Figure 12). This tungsten is the result of vaporization of the tungsten wire-basket.

Figure 11. General view of plug end from Figure 7.

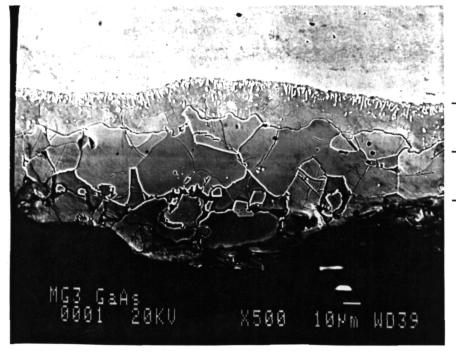
0.022-0.06 mm (0.04 mm ave)
Mo + Ga White spots (Mo + As)

Figure 59. Reaction region between TZM and GaAs after 28.17 hr.
